Rose Park South Historic District Design Guidelines

# Rose Park South Historic District Design Guidelines

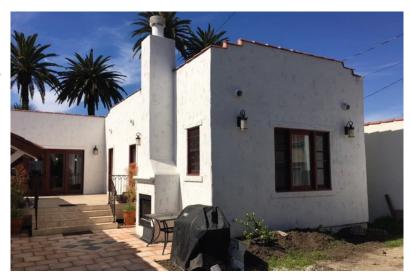
A compatible Spanish Colonial Revival addition to the rear.

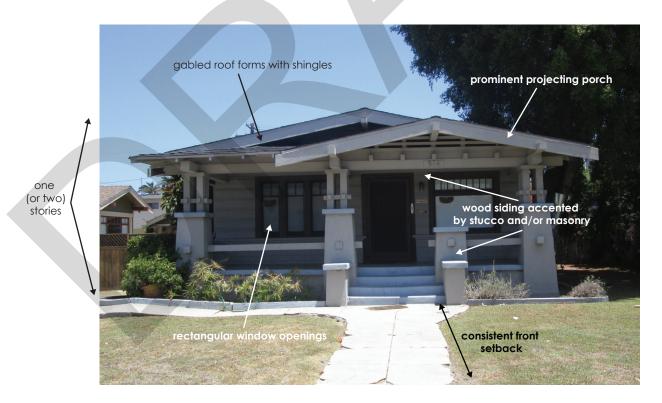
The contributing residences within the Rose Park South Historic District are varied in style, but the majority are Craftsman in style, with front-gabled roofs and wood cladding. They are primarily one story in height, although there are existing two-story properties in the district. Property owners planning new construction should consider including features like a gabled roof, wood cladding, prominent porches and rectangular openings in their design, and anticipate conforming to the prevailing height and setback in the district, especially that of contributing properties immediately adjacent to the proposed new construction. See below for a diagram of these features.

New construction is expected to reasonably "blend in" with its surroundings, where feasible, but is not required to exactly match the contributing buildings. In fact, matching an existing design too closely is discouraged, in order to prevent the new building from being mistaken for an original historic building in the future; however, the new construction should generally take cues from the contributing building to fit into the district more harmoniously.
